NONDESTRUCTIVE EVALUATION OF METAL MATRIX COMPOSITES.(U)

MAY 82 S W SCHRAMM, I M DANIEL

NONDESTRUCTIVE EVALUATION OF METAL MATRIX COMPOSITES

FINAL REPORT

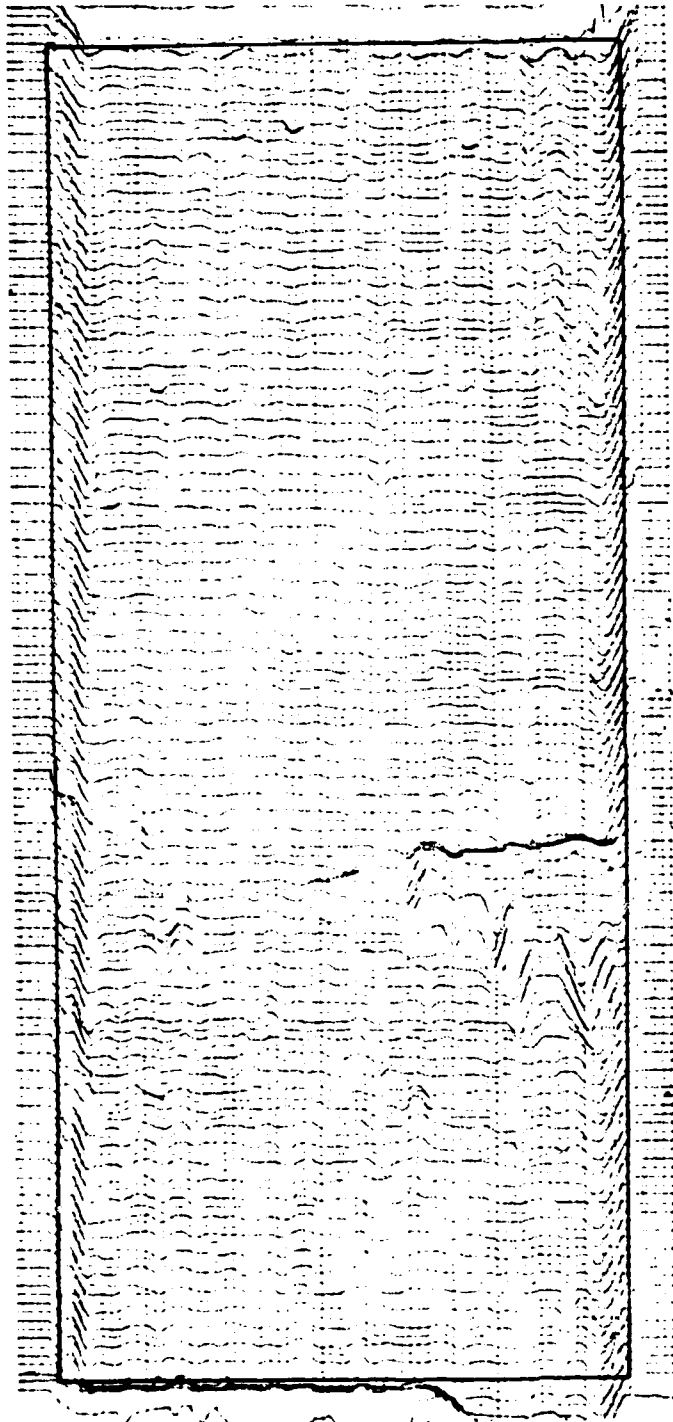
Figure 66. Analog C-scan of FP/Mg Specimen 7-2 (matrix fracture), 5 MHz transducer in pulse-echo mode.

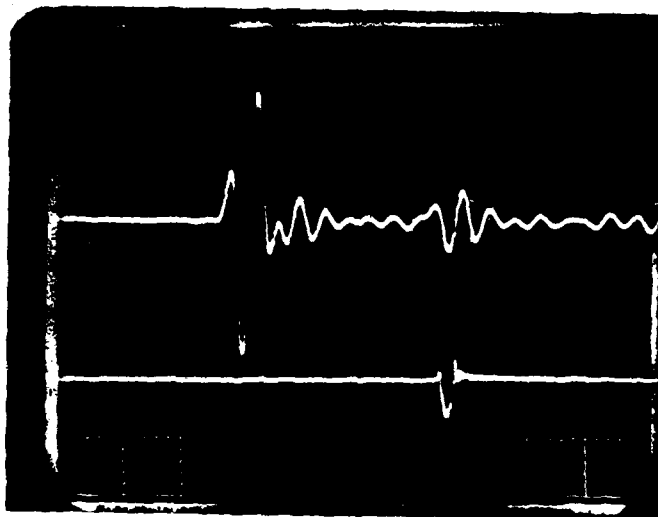
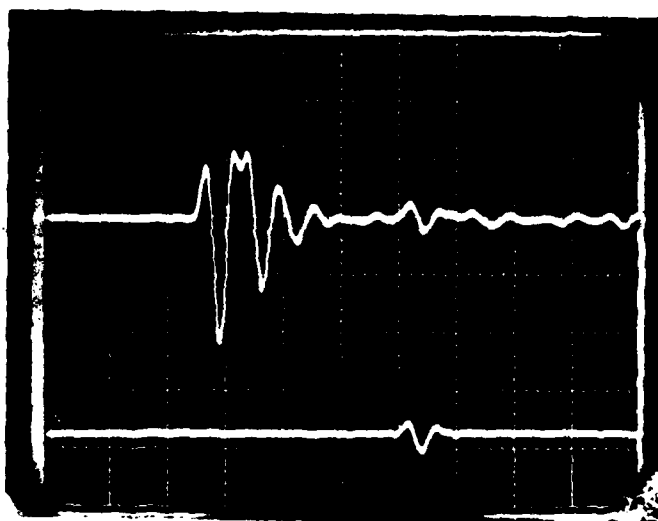
Figure 67b shows a pronounced change in the shape of the front-face reflection and the amplitude of the back-face reflection of the ultrasonic waveform within the area of matrix fracture. The front-face reflected pulse shape is unique to any of the others shown previously for flawed locations of the FP/Mg composite material. A visual inspection of Specimen 7-2 did not reveal any surface irregularities which could have caused the change of the front-face reflection. This indicates that the matrix fracture was located near the front-face of the specimen through-the-thickness and was wave energy dissipative. The wave energy dissipation conclusion is based on the reduction of amplitude of the front and back-face pulses.

Figure 67. Amplitude-time records (A-scans) of ultrasonic pulse at two locations of Specimen 7-2 (matrix fracture). (a) Unflawed location, (b) flawed location. (0.5 V/div, 0.5 μ s/div.) 5 MHz transducer in pulse-echo mode.

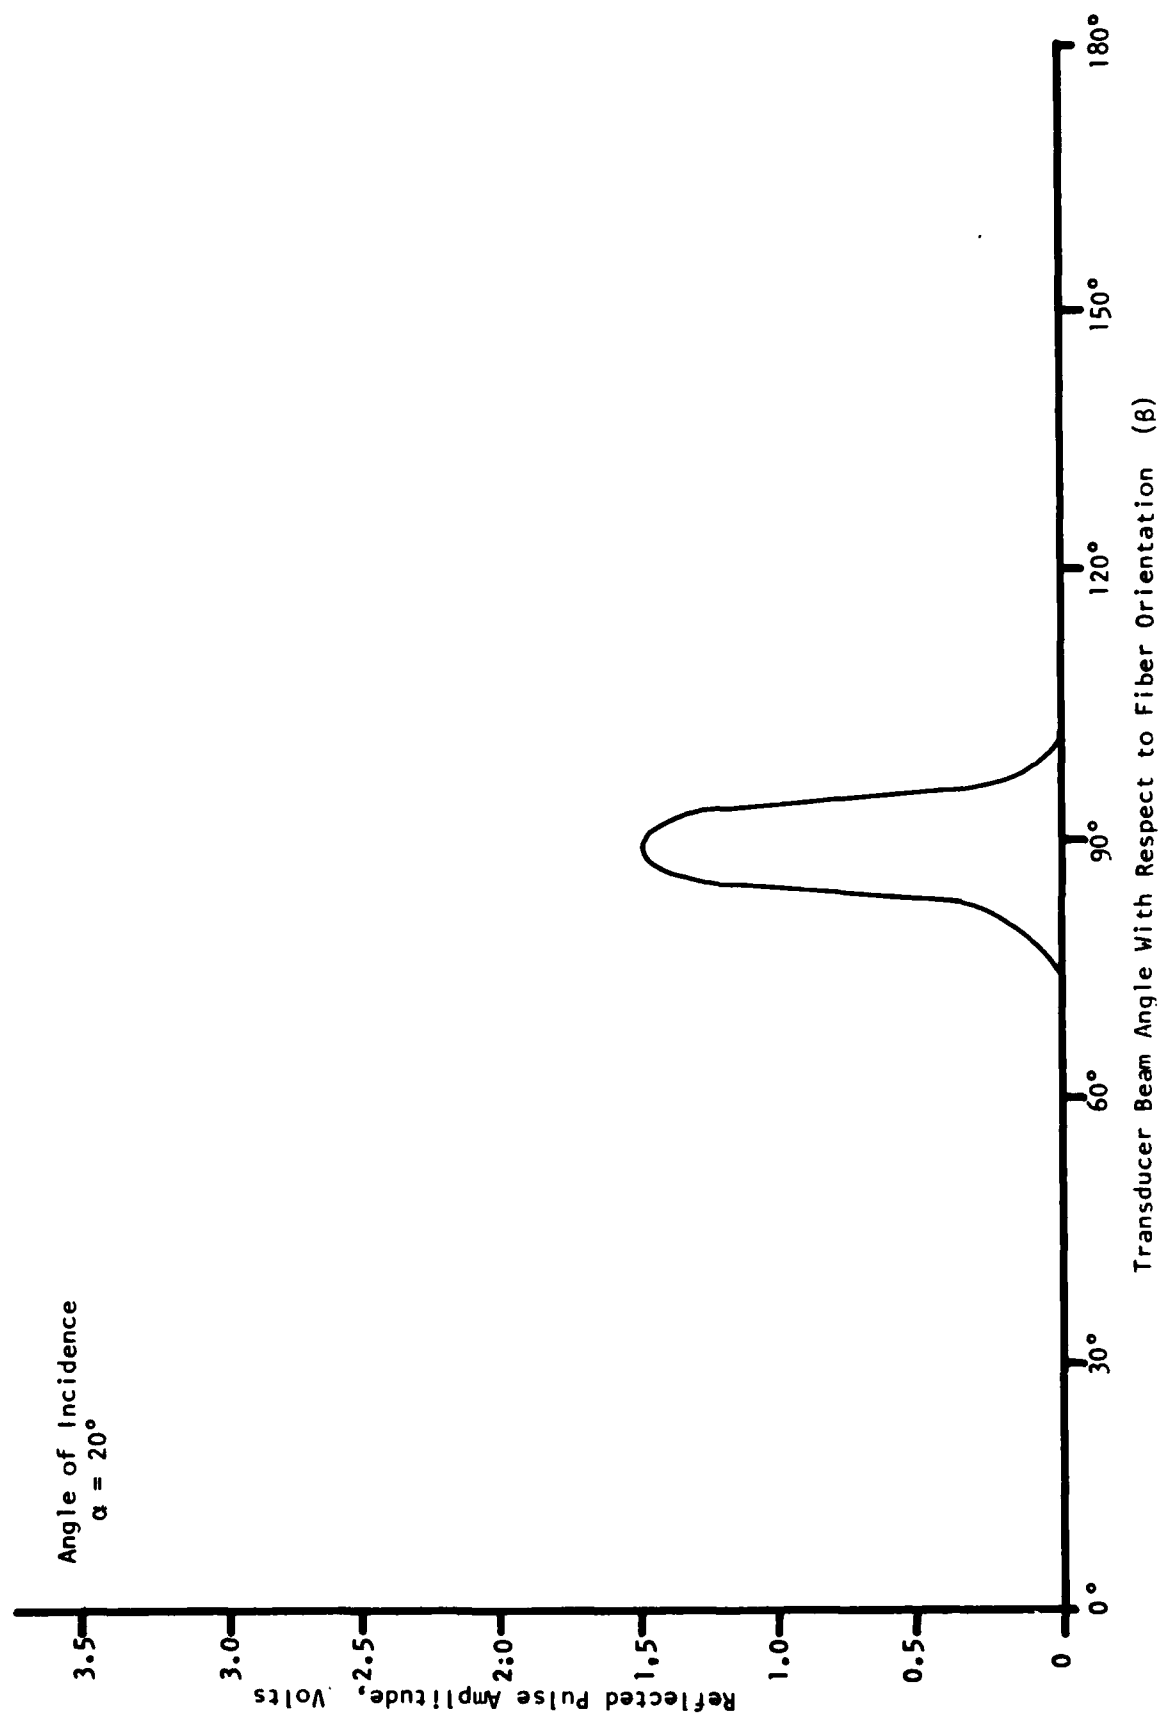
Figure 69. Ultrasonic backscattering curve of FP/Mg specimen with matrix fracture (Specimen 7-2)
